# VISUAL IMPACT GUIDE

*Improve Results through Improved Awareness*

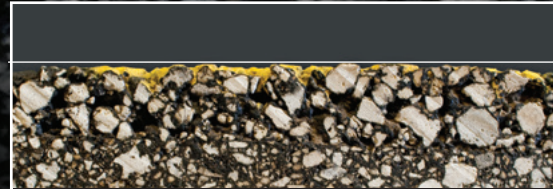
Cross Section of A/C Base

# ROAD SURFACE PRIOR TO MARKING REMOVAL

Marking penetration into pavement surface

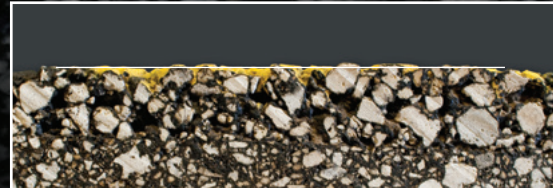
Cross Section of A/C Base

# LEVEL 1 REMOVAL USING UHP WATER BLASTING

- The Goal: 98% removal (*2% remains*)
- No damage
- Some discoloration has occurred

Allowing 2% to remain tells the operator he has reached maximum removal speed.

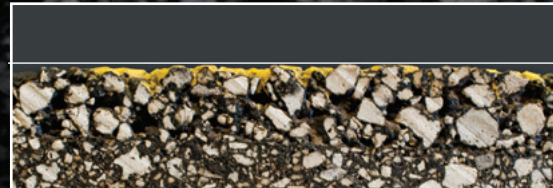
Cross Section of A/C Base

# LEVEL 2 REMOVAL USING UHP WATER BLASTING

- Acceptable
- Minimal scarring
- Very little aggregate or fines removed

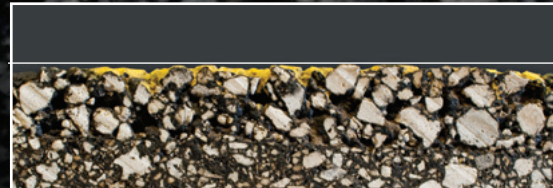
Cross Section of A/C Base

# LEVEL 3 REMOVAL USING UHP WATER BLASTING

- Moderate scarring
- Aggregate and fines have obviously been removed
- Some rutting is occurring

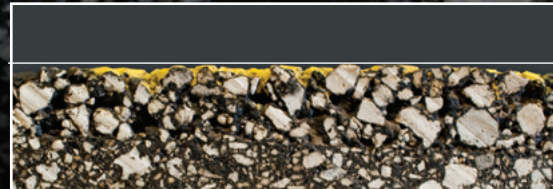
Cross Section of A/C Base

# LEVEL 4 REMOVAL USING UHP WATER BLASTING

- Unacceptable
- Call your supervisor
- Do not continue unless directed in writing by the engineer or owner
